SAND REPORT

SAND2004-4083
Unlimited Release
Printed August 2004

Failure Analysis and Surety Design of Composite Patching Systems

Dr. Sameer Hamoush)

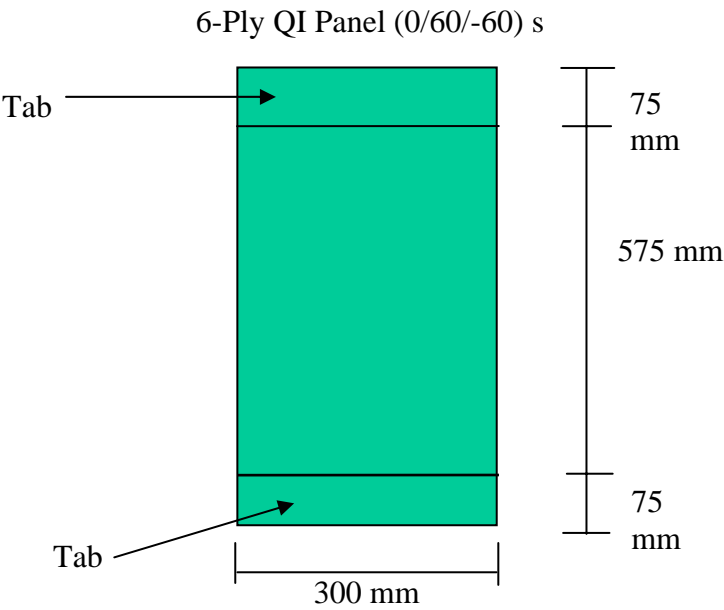
Figure 1. Full Scale panel.

Figure 1 shows a 6-ply quasi-isotropic laminated panel selected for this study. The selected configuration allows a reasonable panel thickness for repair and provides reasonable over all panel size that can be tested in the laboratory. The challenge in the full-scale testing is designing the grips that provide uniform stress distribution across the panel section. Three solid laminates were tested to validate the grip design and evaluate the strain along the mid-section. Panels were dented at the central point to present a damage zone. The damage area was removed according to Boeing design manual and three specimens were tested to evaluate the residual strength of the damaged panels. Scarfing was performed on four additional damaged panels and patch repairs were applied. The scarfing was performed on one side of the panel with 12.5 mm steps. Figure 2a shows the scarfed laminated panel that was performed layer by layer and Figure 2.b shows the repaired panels after the application of the patch. The retained strength was also evaluated by testing four repaired panels in which one panel was repaired with wrong plies orientations. All repairs performed in this program complied with Boeing Standards.

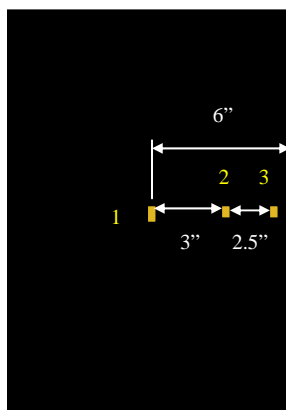
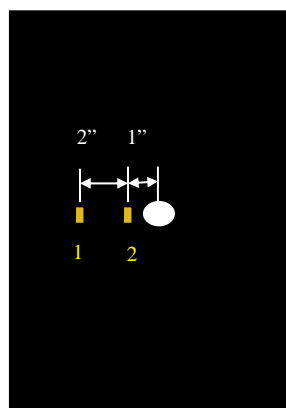
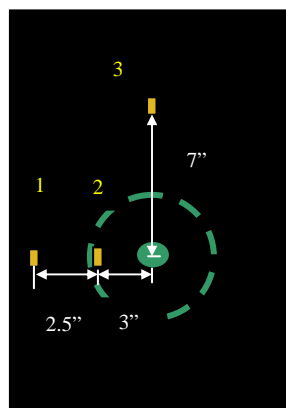
Figure 4: Locations of Strain Gauges

Schematic diagrams for the strain gauges locations on one pristine panel, one damaged and one repaired panel are shown on Figure 4.

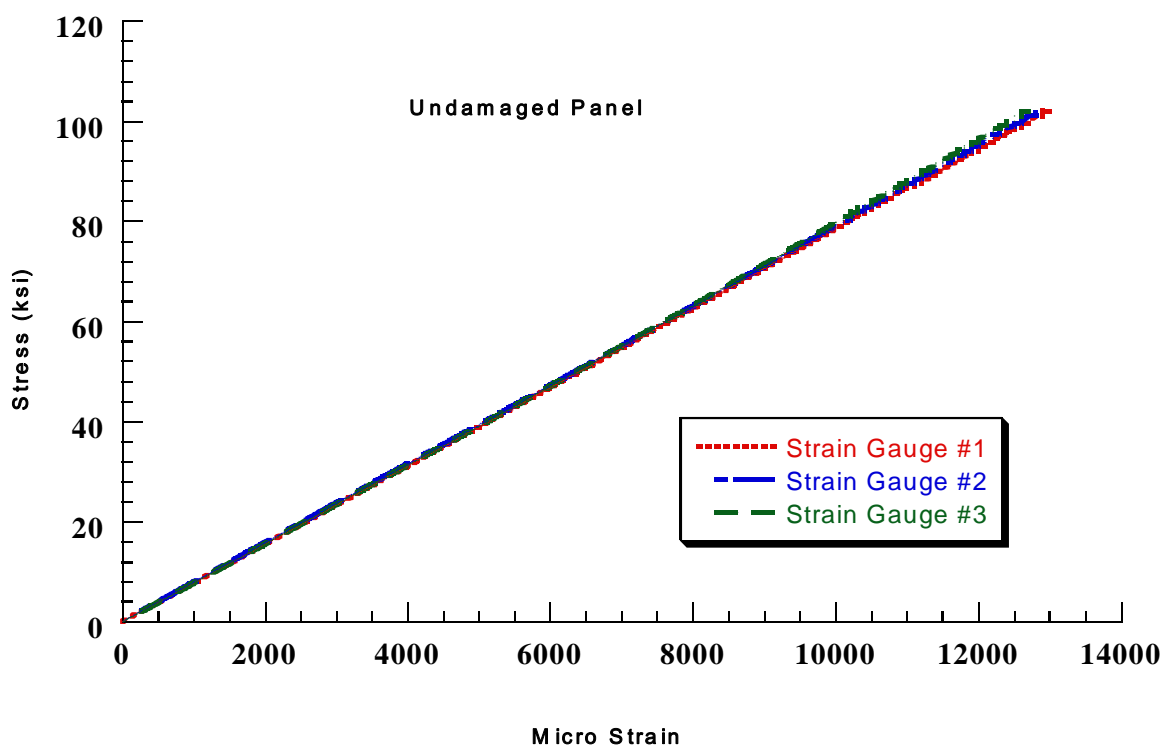
Figure 5a Pristine Panels

Figure 5: The stress-strain diagrams for the gauges mounted on (a) Pristine panel, (b) damaged panel and (c) repaired panel.
